APPENDIX D: **Case Study Area Summaries**

CASE STUDY 1: I-395 / LANDMARK MALL

CASE STUDY 2: SEMINARY ROAD / HAMMOND MIDDLE SCHOOL

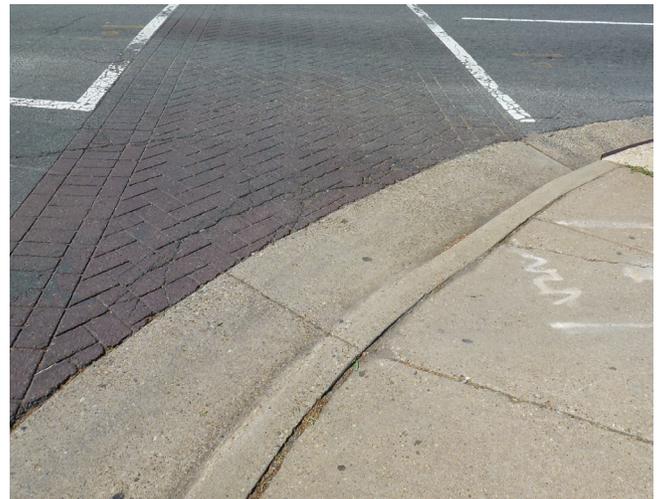
Non-compliant curb ramp in Alexandria

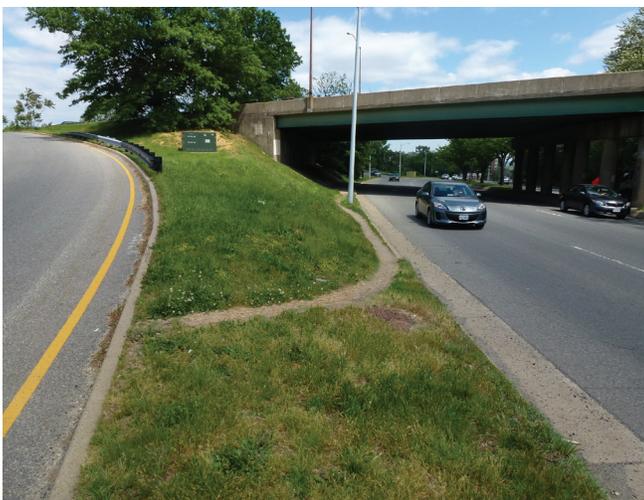
Goat path along Duke Street

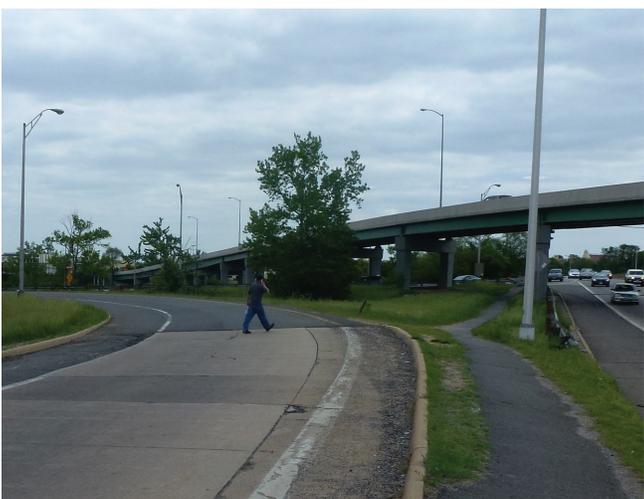
Pedestrian crossing the middle of the on-ramp

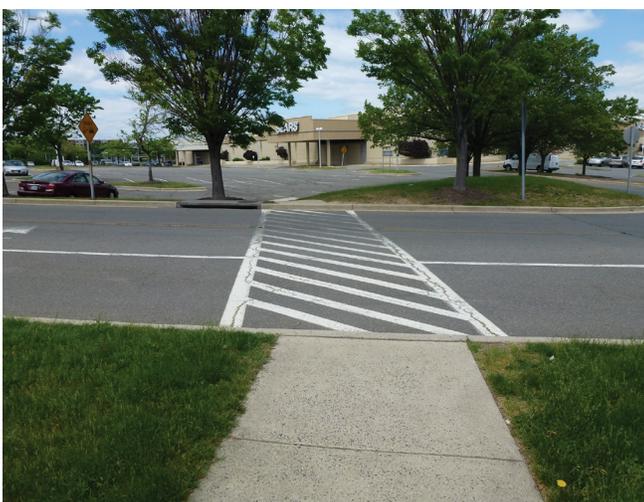
Crosswalk lacking ADA ramps

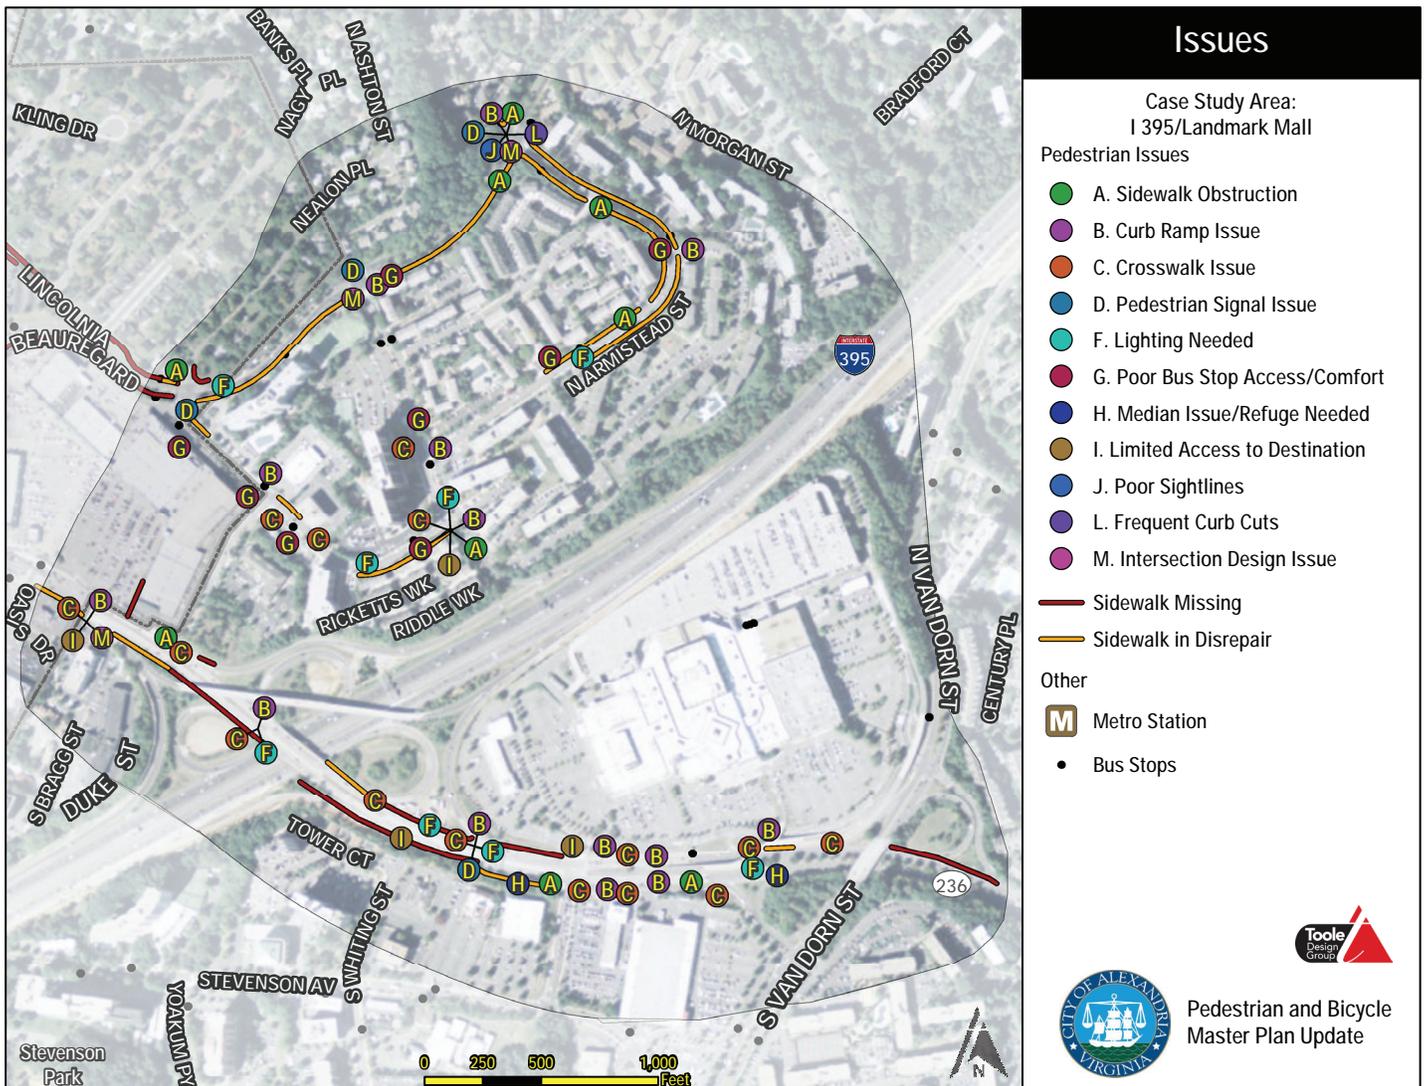
Figure 1: Map of Issues Identified

Table 2 shows the types and frequency of issues observed during the field work in the I-395/Landmark Mall Case Study Area. As in all the Case Study Areas, sidewalk obstructions and disrepair, crosswalks, and curb ramps are the most prevalent pedestrian infrastructure issues. Sidewalks exist along most, though not all, streets and are typically five feet wide. Similarly, most --but not all-- of the sidewalks have buffers. Other notable issues in this corridor include poor lighting and poor bus stop access, as shown in Figure 1.

Within the Case Study Area, the most challenging corridor for pedestrians is along Duke Street between Beauregard Street and South Van Dorn Street. Sidewalks are missing in many locations, and where sidewalks do exist they are in disrepair or are too narrow to create a comfortable walking environment, given the surrounding context and vehicle speeds. Many pedestrians were observed along Duke Street despite the uncomfortable conditions. Worn paths in the dirt/grass were observed in most locations where the sidewalk is discontinuous, demonstrating a need for more permanent infrastructure. The City is currently completing a sidewalk project along Duke Street from Oasis Drive to Walker Lane, which is a step toward addressing the connectivity issues in this area.

Another important issue in this Case Study Area is the limited pedestrian access to the Landmark Plaza shopping center as well as the Landmark Mall. Although there is a recently restriped crosswalk on Duke Street at South Walker Street, the connecting sidewalks are narrow or in disrepair and there is not an ADA accessible route to the Mall from the nearest bus stop on Duke Street.

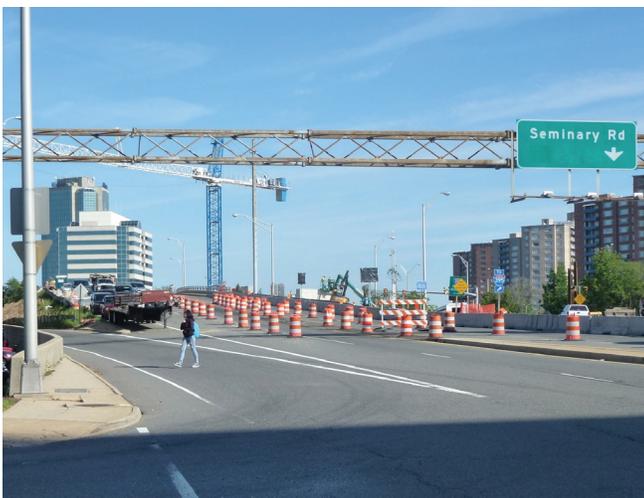
Student crossing mid-block on Seminary Road at Kenmore Avenue near I-395 entrance

Within the Case Study Area, one of the most challenging locations for pedestrians is the Seminary Road crossing at Kenmore Avenue. During the project field work, numerous pedestrians were observed crossing mid-block on Seminary Road to access the bus stop and shopping centers on Kenmore Avenue and Library Lane. This condition likely results from the concentration of higher density housing to the south of Seminary Road, the commercial development and bus stops to the north, and the long distances between marked crossings in this area.

To help with the issue of people crossing mid-block on Seminary Road at Kenmore Avenue, a near-term recommendation is to consider relocating the bus stop on the north side of the street closer to the signalized intersection of Seminary and Library Lane. Longer term, the City could evaluate the potential for a new traffic signal or pedestrian activated signal at Seminary and Howard; however, the close proximity to the adjacent signal at Library Lane may make this infeasible.

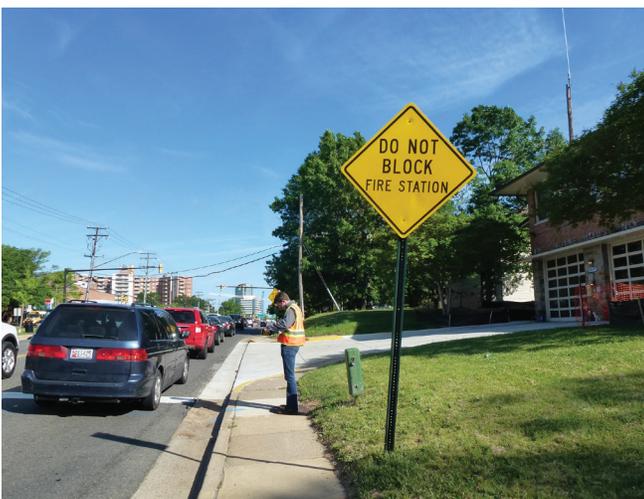
Traffic outside Hammond Middle School blocking the fire station

Walkability and pedestrian safety in this Case Study Area is particularly important due to the presence of Hammond Middle School. Alexandria has an active Safe Routes to School program that aims to support increased walking and bicycling to school. Several curb ramps and crosswalks in front of the school need improvement, and the field work team noted a lack of visible signage alerting parents to the school zone, especially at the west end of the school zone. Another challenge in this area is that vehicles back up on Seminary Road in front of Hammond Middle School as parents wait to drop off/pick up their children. This situation blocks the sidewalks and creates the potential for conflicts between the queuing vehicles and other traffic.

To improve pedestrian access and safety near Hammond Middle School, additional highly-visible school zone signage is recommended. School officials should also increase enforcement of school drop off/pick up zones to minimize backups on Seminary Road.

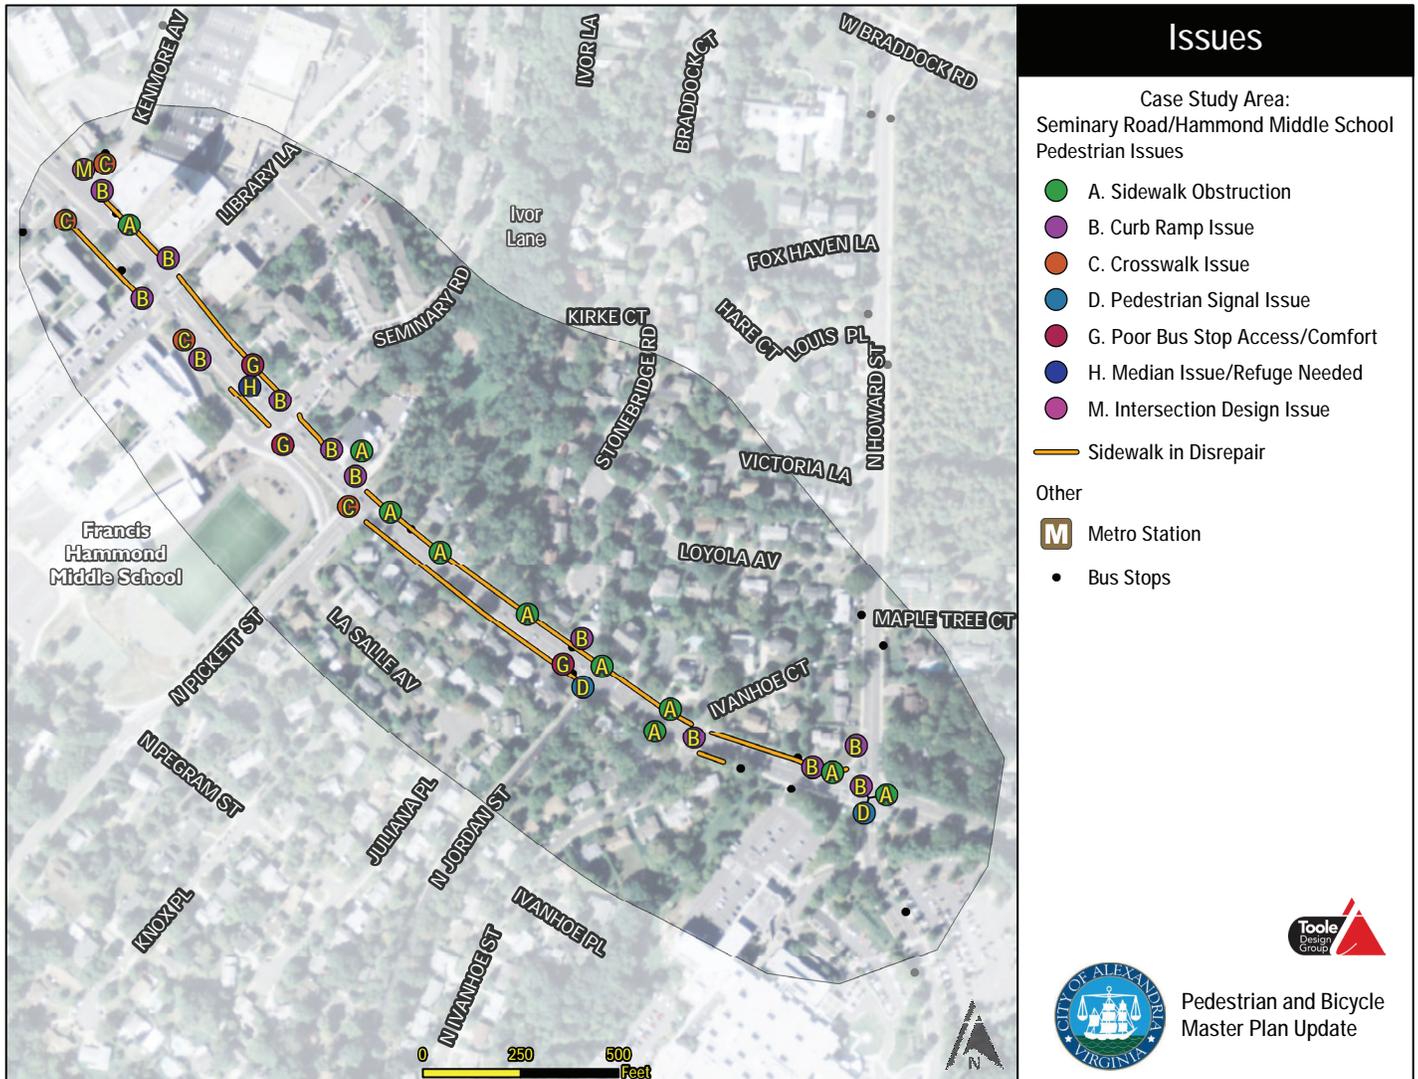
Figure 3: Map of Issues Identified

As in all the Case Study Areas, curb ramps, sidewalk obstruction/disrepair, missing or narrow sidewalks, and crosswalks are key issues in the Seminary Road/Hammond Middle School area. Sidewalks exist on both sides of the streets and vary in width from four and six feet. Sidewalk buffers of between four and six feet exist on some segments of Seminary Road and nearby local streets, but in some instances buffers are narrow given the speed and volume of traffic. Additionally, many sidewalks and curb ramps are not ADA compliant, and several intersections lack marked crosswalks. Other issues in this corridor include poor bus stop access and inaccessible or broken pedestrian signals, as shown in Table 4 and Figure 3.

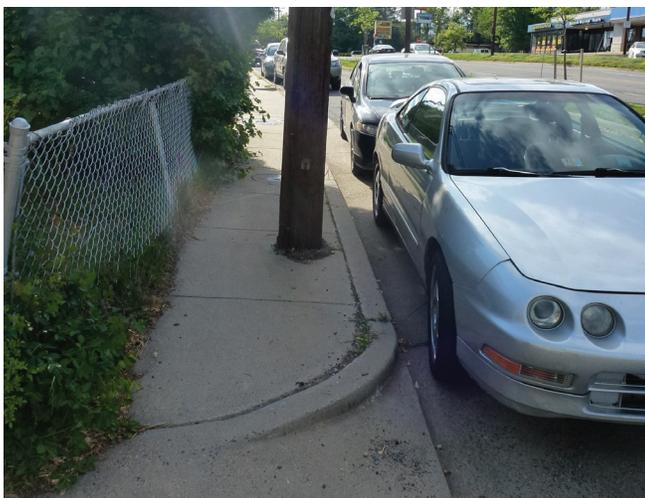
Sidewalk obstruction and curb ramp issue

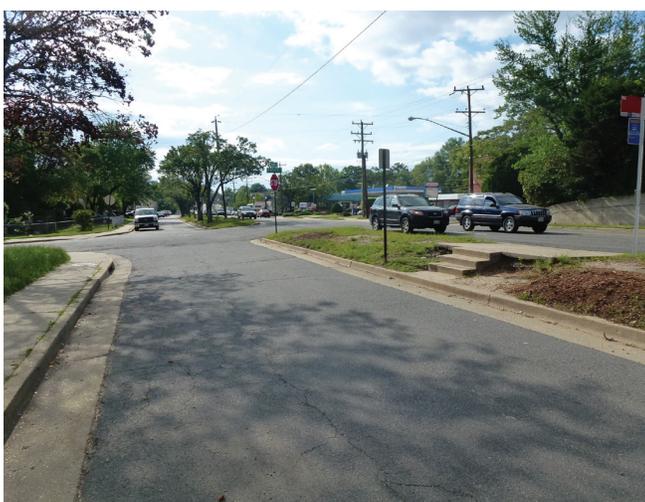
Non-ADA compliant bus stop

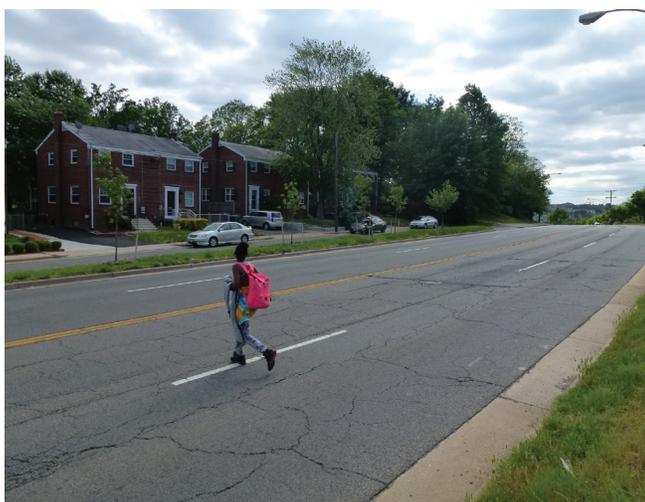
Student crossing mid-block across Duke Street to local access road

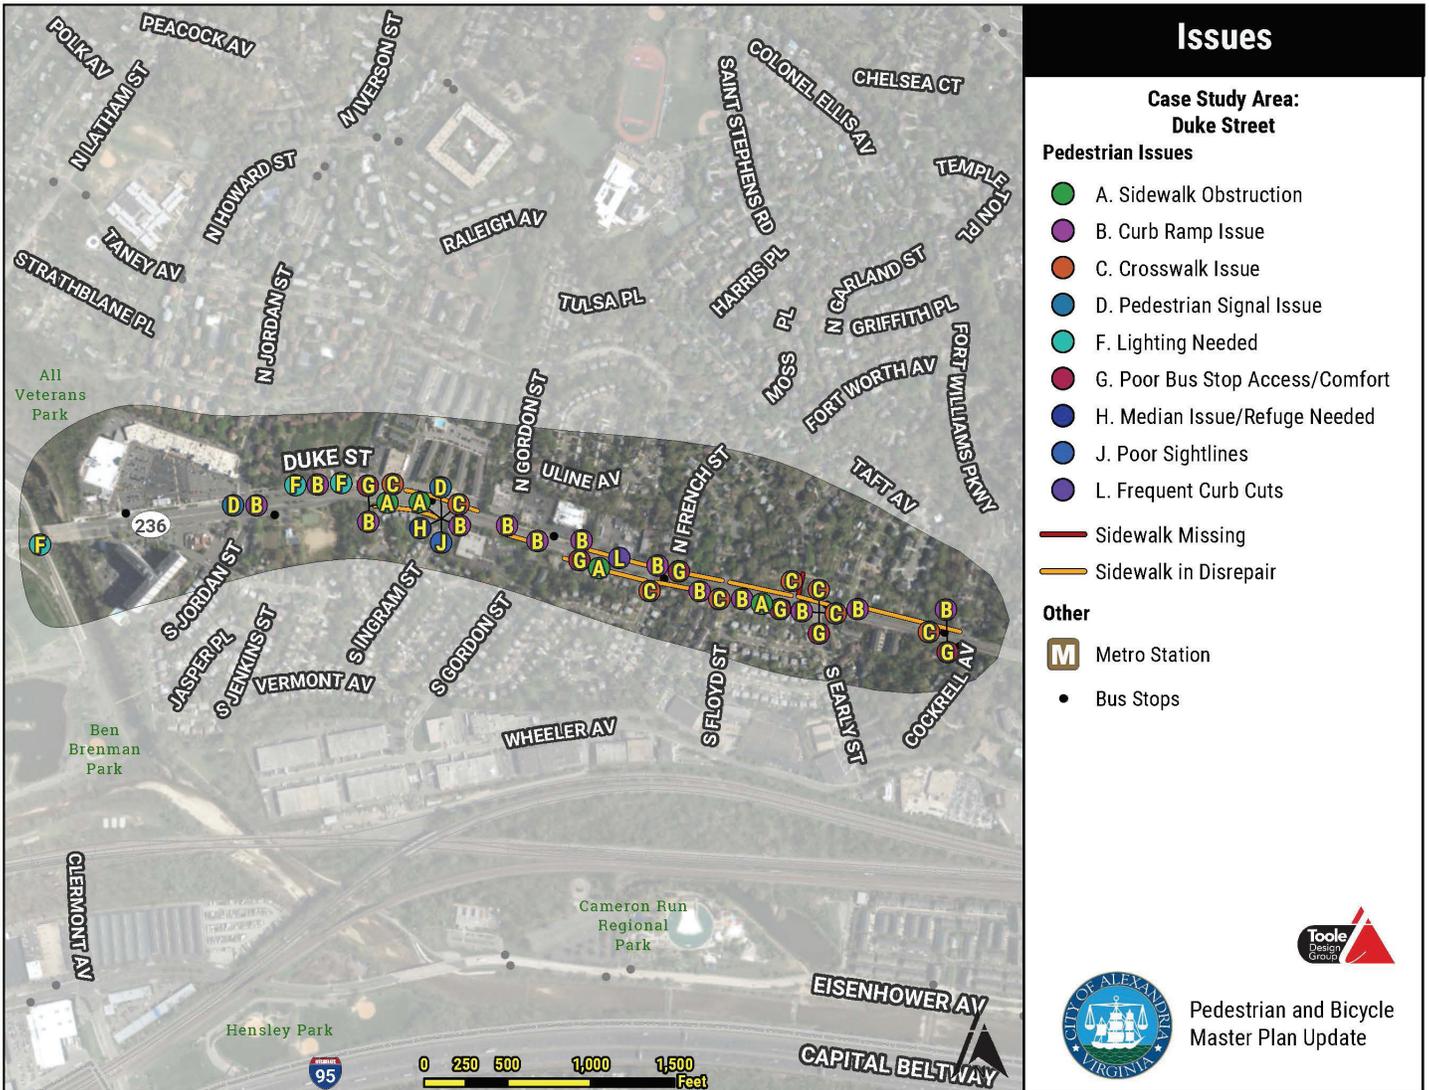
Figure 5: Map of Issues Identified

As shown in Table 6 and similar to other Case Study Area, curb ramps, crosswalks, sidewalk obstruction/disrepair, and missing or narrow sidewalks are key issues in the Duke Street Corridor. Other issues in this corridor include poor bus stop access/comfort and poor lighting, as shown in Figure 5. Sidewalks exist on both sides of the street in some, but not all locations and vary in width between five and six feet. However, the sidewalks are not buffered from traffic in many locations, and multiple driveways and access roads create conflict points for pedestrians. Additionally, many sidewalks and curb ramps are not ADA compliant. Several bus stops lack shelter, seating, and curb ramp access from the adjacent side sidewalk.

The most problematic segment of the Case Study Area is Duke Street between Ingle Place and Gordon Street. This segment has a two-way access road on the north side of Duke Street, and the vehicle lane configuration leads to numerous potential conflict points with other vehicles, pedestrians, and bicyclists. Another issue with this segment is that there is no pedestrian accommodation at the intersection of Duke Street at Ingram Place. The nearest signal with crosswalks, pedestrian signal heads, and curb ramps is 400 feet away, making it difficult for pedestrians to safely cross in this portion of the corridor. Additionally, there is poor access to the existing bus stops in this segment due to narrow sidewalks on the south side of Duke Street.

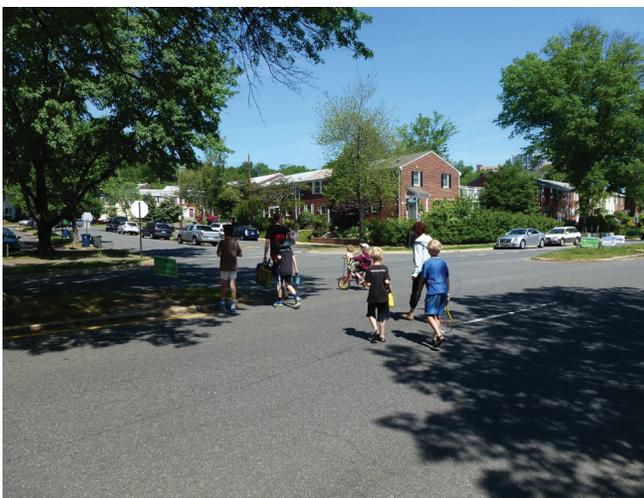
Group of kids crossing mid-block across Commonwealth Avenue to Ansell Street

There are a few intersections in the Case Study Area that present particular challenges for pedestrians crossing the street. There is currently no crosswalk on Kennedy Street at Ansell Street, despite the fact that many families in this area frequently visit the Goat Hill Park playground on the north side of Kennedy Street, and Colasanto Park at the end of Ansell Street on Commonwealth Avenue. The Neighborhood Parks Improvement Plan included a recommended crosswalk to improve access to Goal Hill Park. Additionally, there is no crosswalk on Commonwealth Avenue at Ansell Street leading to Colesanto Park.

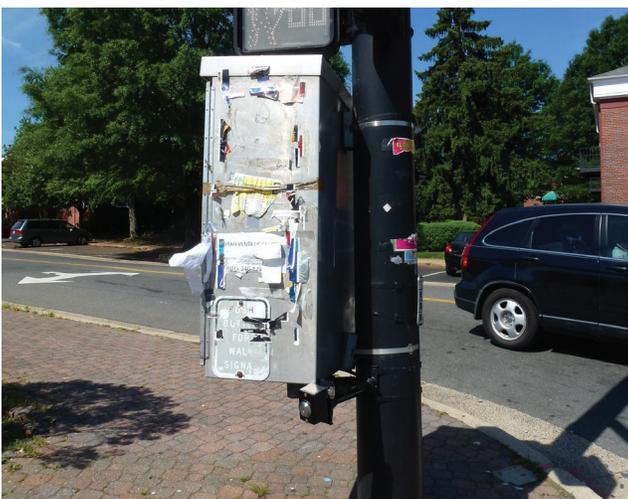
Obstructed pedestrian crossing signal button and signage on Mt. Vernon Avenue

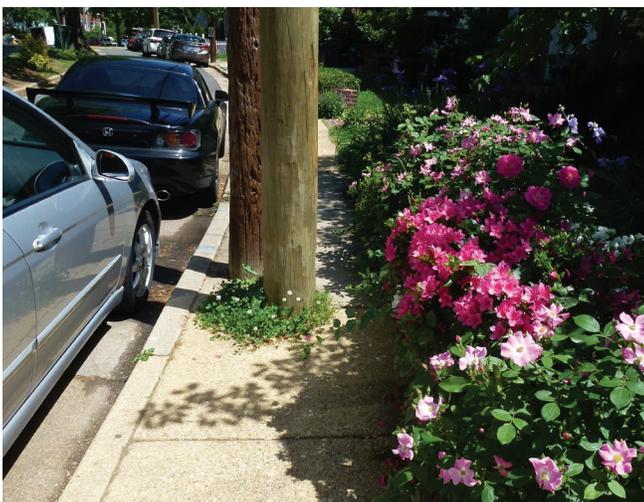
Sidewalk obstruction on a local street near the Mt. Vernon Commercial District

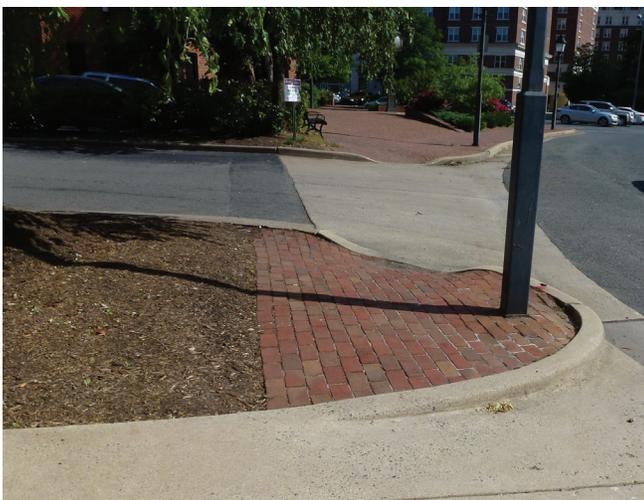
Missing and non-ADA compliant curb ramps

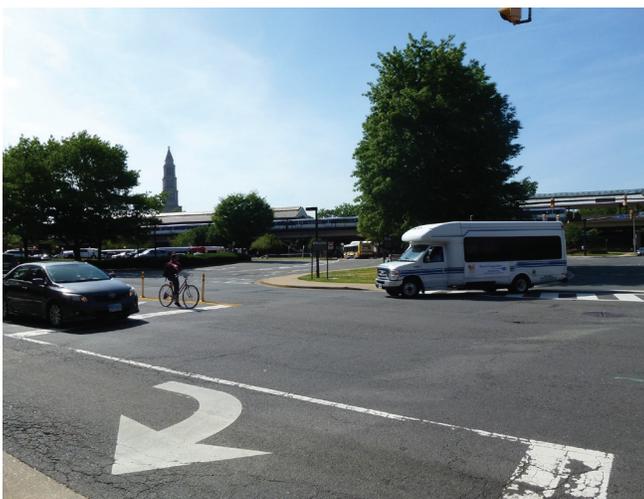
Challenging intersection near King Street Metro

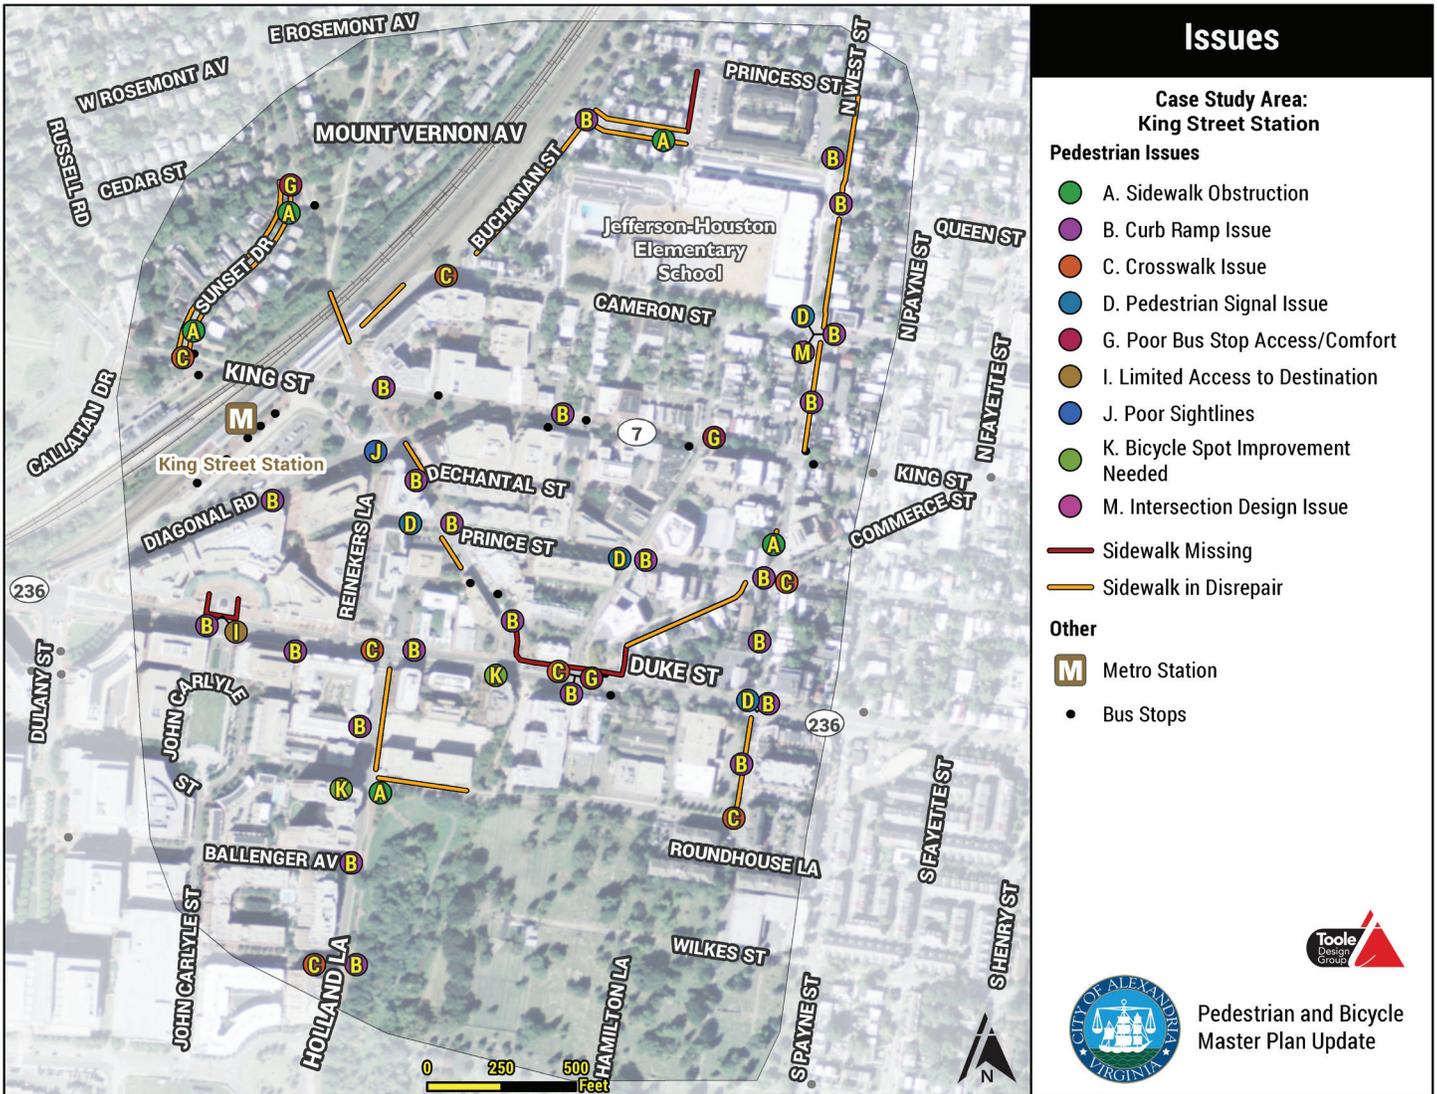
Figure 9: Map of Issues Identified

While the neighborhood surrounding King Street Station is relatively walkable, there are still opportunities to improve the pedestrian environment. As shown in Table 10, curb ramps are a particular issue in this area. Curb ramp designs in Old Town vary greatly, and many of the existing curb ramps are not compliant with national accessibility standards. While sidewalks exist on both sides of the street in most areas, there are a few gaps and/or narrow conditions, as well as many instances of obstacles or maintenance issues on existing sidewalks (see Figure 9).

Smaller, spot issues exist throughout the Case Study Area, especially regarding the frequency and quality of crossings. Crosswalks are missing in a few key locations, such as King Street at Sunset Drive, where there is a playground, and Cameron Street near Buchanan Street, where there is an entry point to a walking path. Similarly, corridors like King Street lack pedestrian signals except for at major signalized intersections like Henry Street, Patrick Street, and near the King Street Metro Station.

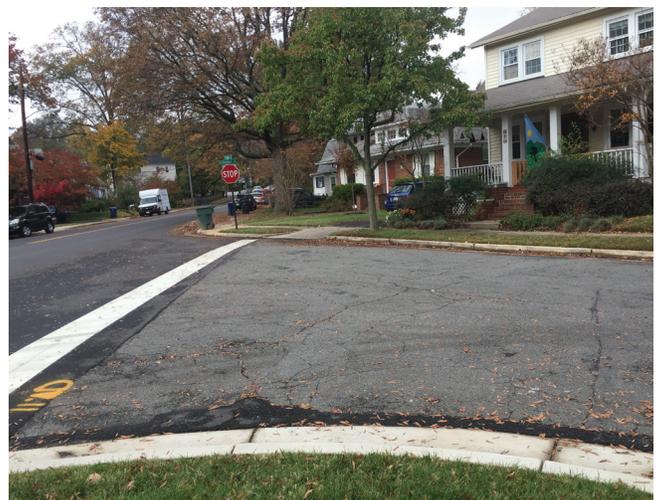
Missing crosswalks and curb ramps on residential areas

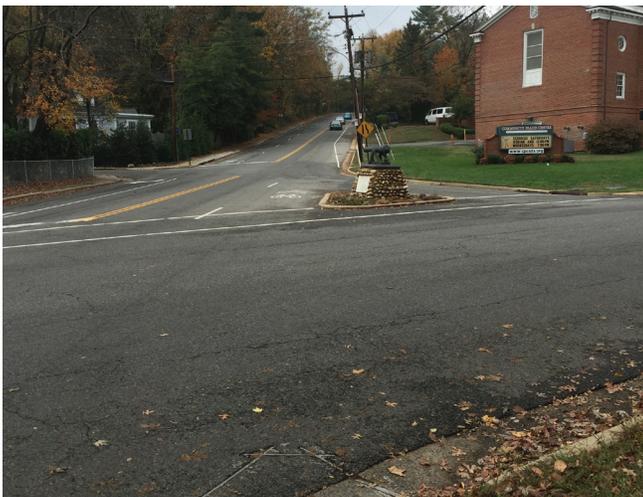
Missing crosswalk at intersection of Russell Road and Braddock Road

Following a pedestrian fatality at this intersection in 2015, the City made a number of changes that aim to improve safety in the area. The City installed “No Turn on Red” signs and a leading pedestrian interval at the signal, which will allow pedestrians to start crossing before vehicles enter the intersection.

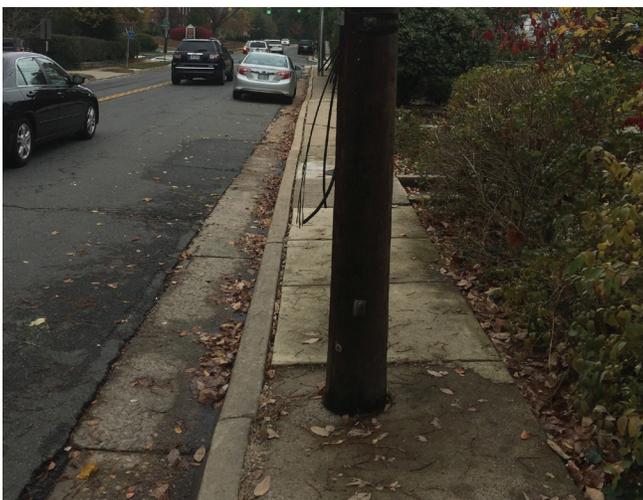
Utility post obstructing existing sidewalk

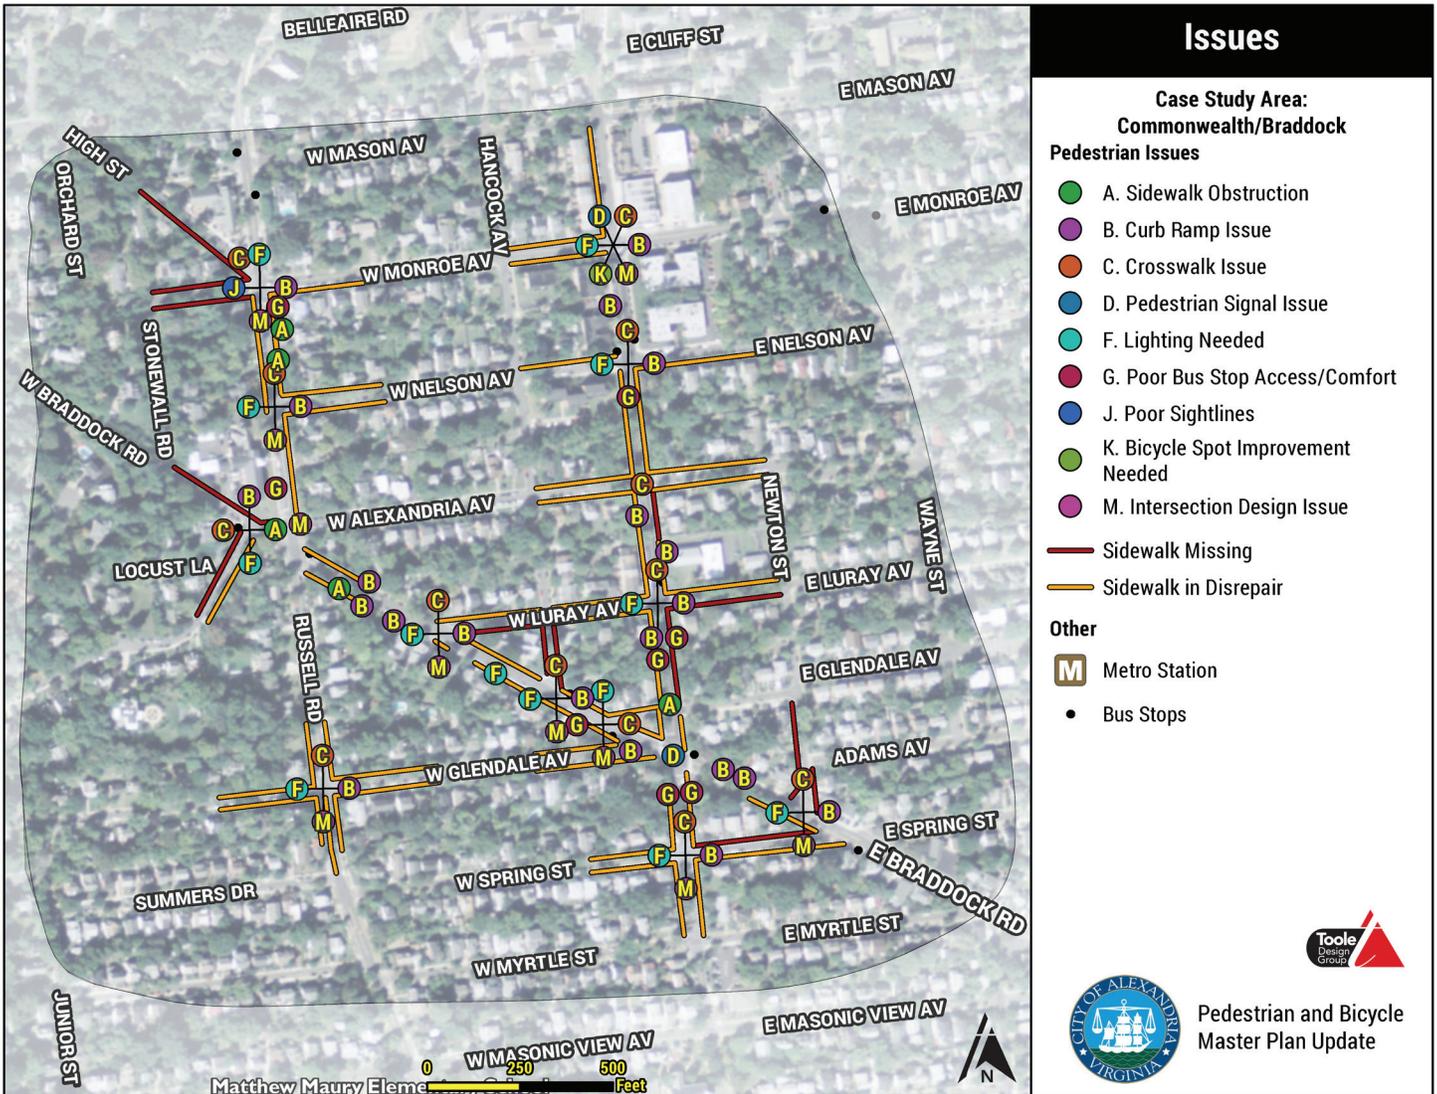
Figure 11: Map of Issues Identified

The Study Team identified a number of barriers to walkability in the Commonwealth Avenue/Braddock Road Case Study Area. As in the other Case Study Areas, the primary issues include curb ramps, sidewalks with obstructions or in disrepair, missing or narrow sidewalks, and unmarked crosswalks. Sidewalks are present on both sides of the street in most areas, though they are typically substandard width. Sidewalk widths range from four to six feet, and many segments also have a sidewalk buffer. However, many sidewalks and curb ramps are not ADA compliant. In addition, many crosswalks are unmarked, and several that are marked lack high-visibility striping. Many bus stops in the area lack shade or seating for riders.

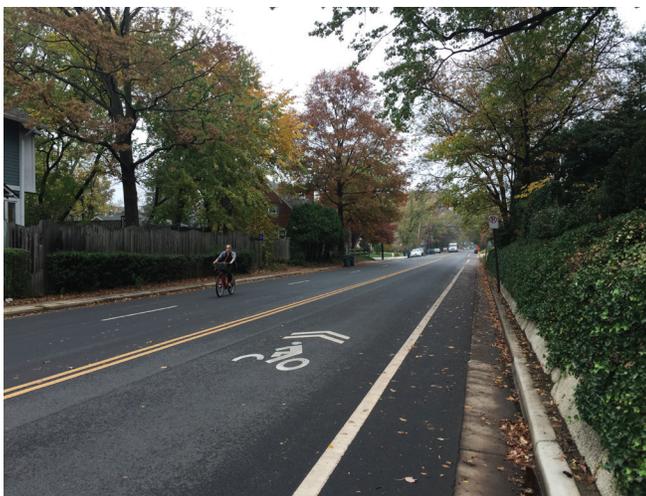
Missing sidewalk near Commonwealth Avenue and Glendale Avenue
